Property Inspection Report

1234 School House Road
Yourtown, US 12345

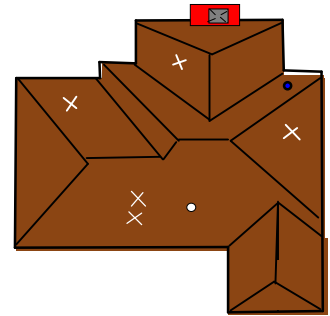
2. Roof Diagram

4. Defective **Material:** Fiberglass shingle Nail popping through shingle surface in various locations causing potential water intrusion (see diagram above marked "x")

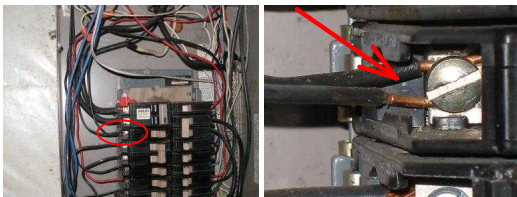
8. Acceptable Smoke Detectors: Battery operated
- Basement Electric Panel

9. Acceptable Manufacturer: Cutler-Hammer
10. Maximum Capacity: 100 Amps
11. Acceptable Main Breaker Size: 100 Amps
12. Defective Breakers: Copper Double taps are present at breakers. These circuits need to be moved to their own circuit breaker and cannot share a breaker. It is recommended that a qualified electrician inspect the new circuits and properly connect the new circuits to an individual breaker for each circuit

9. **Ground:** Plumbing and rod in ground insufficient grounding - missing ground cable at ground rod connection strap, Correction by a licensed electrician is recommended
10. **Basement Electric Panel Breakers:** Copper Double taps are present at breakers. These circuits need to be moved to their own circuit breaker and cannot share a breaker. It is recommended that a qualified electrician inspect the new circuits and properly connect the new circuits to an individual breaker for each circuit

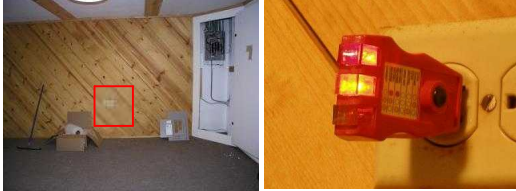
Electrical: (continued)

8. Defective **Electrical:** 110 VAC Reversed polarity exists at several basement outlets

17. **Main Basement Electrical:** 110 VAC Reversed polarity exists at several basement outlets
18. **Main Basement Moisture Location:** Various spots along perimeter walls
19. **Main Basement Basement Stairs/Railings:** Wood stairs with no handrails

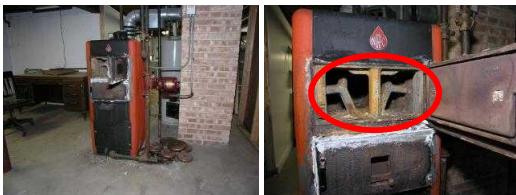
Basement Heating System

1. Marginal Heating System Operation: Recommend replacement Boiler system is antiquated and lacks safety features found on newer units including non-sealing combustion chamber which can cause health issues

13. **Basement Heating System Heating System Operation:** Recommend replacement Boiler system is antiquated and lacks safety features found on newer units including non-sealing combustion chamber which can cause health issues

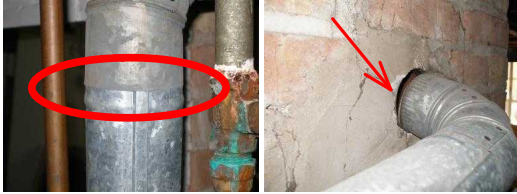
13. Defective **Flue Pipe:** Single wall Install screws at exhaust vent piping fittings, loose piping at chimney

- 21. Main Water Shutoff:** Basement Wrench being used as shut off handle - corrections required
- 22. Gas Service Lines:** Black Iron Missing termination cap at exterior abandoned gas line
- 23. Basement Water Heater Flue Pipe:** Single wall Install screws at exhaust vent piping fittings, loose piping at chimney

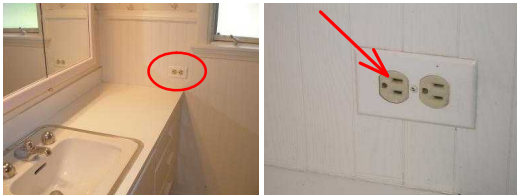
Hall Bathroom

1. Acceptable **Closet:** Single small
2. Acceptable **Ceiling:** Plaster
3. Acceptable **Walls:** Plaster, Ceramic Tile
4. Acceptable **Floor:** Ceramic tile
5. Acceptable **Doors:** Hollow wood
6. Acceptable **Windows:** Wood casement
7. Defective **Electrical:** 110 VAC Non-GFCI circuit, Reversed polarity present
